Manhole Inspection Summary

Manhole # S33CC_026MH

Location Address: **247 CHASE ST**

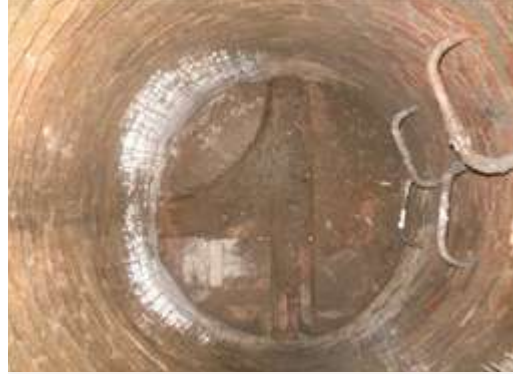
Top View

Corroded and missing steps. Bench and Channel debris.

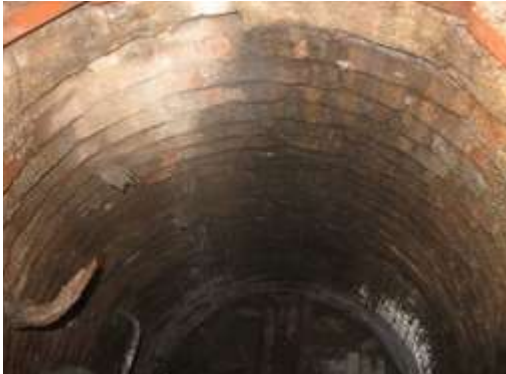
Defect

Corroded and missing steps. Adjustment and Barrel infiltration.

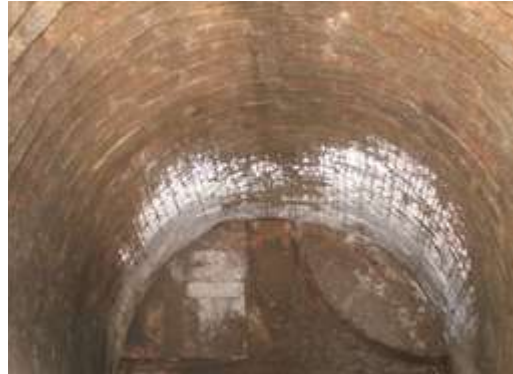
Defect

Barrel infiltration.

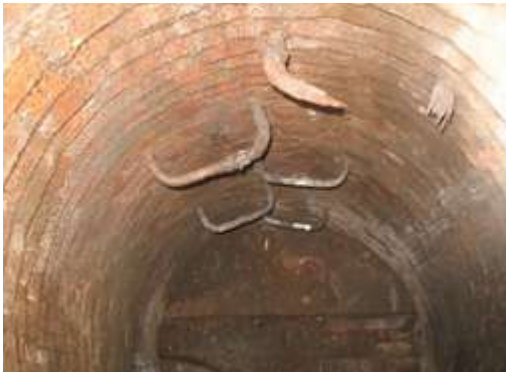
Defect

Corroded and missing steps. Adjustment and Barrel infiltration.

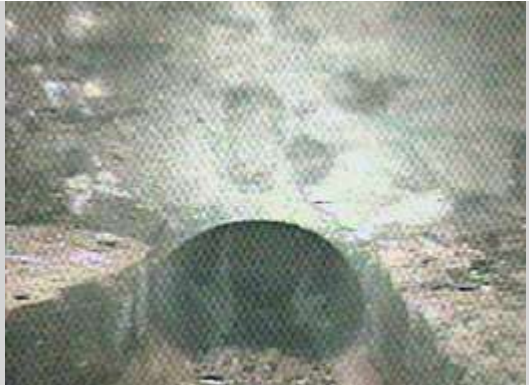
8 in. Circular Gravity Sewer Pipe Out @ 12 O'Clock

Deposits: ☐ None ☒ **Mud** ☐ Sludge ☒ **Debris** ☐ Grease

Silt Depth: **1** (in.) Deposits Extent: **Light**

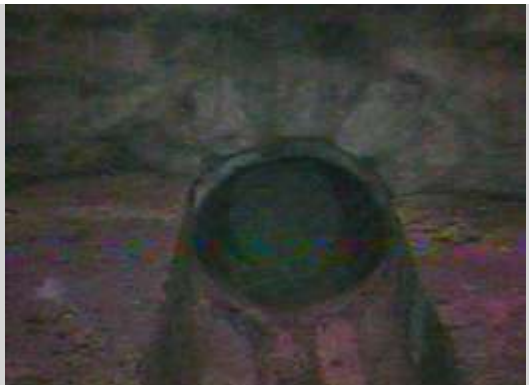
8 in. Circular Gravity Sewer Pipe In @ 6 O'Clock

Infiltration: **Evidence** Pipe Seal Cond: **Unknown**
